**Evaluation of Public Safety at Run-of-River Dams
An Illinois State Wide Program**

JULY 20, 2007

APPENDIX V – Dam Investigations

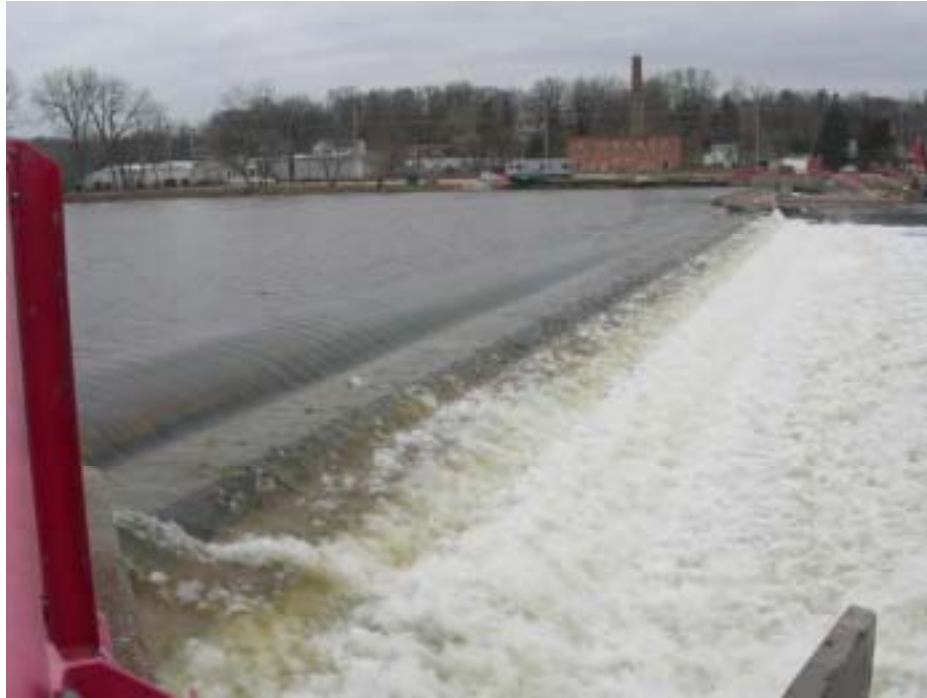
Photo 5.3.12.2 - 7 - Yorkville Dam, Fox River
Right abutment. Newly added steps to dam.

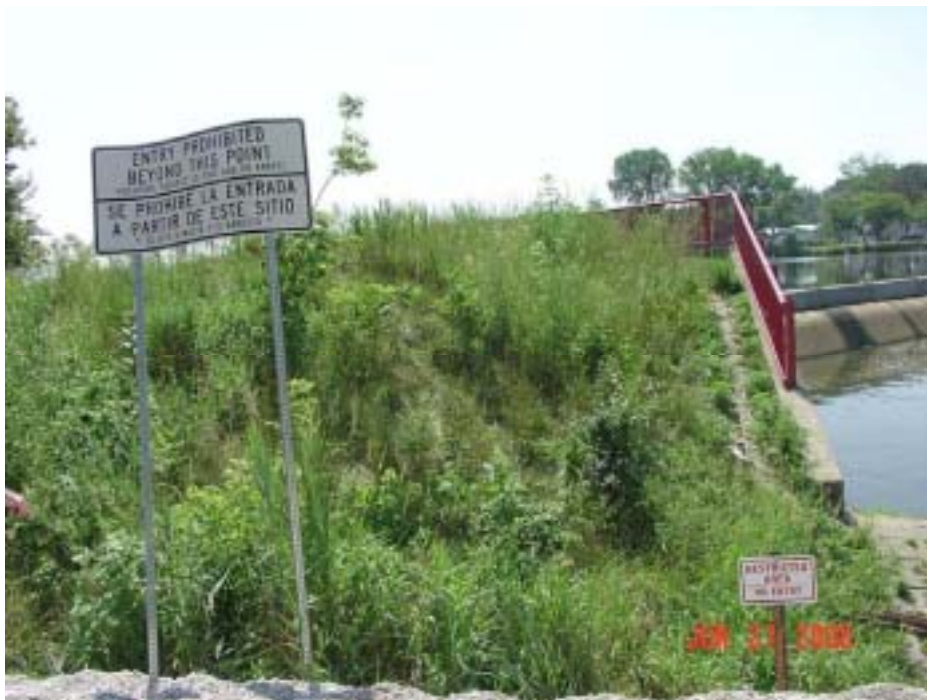
Photo 5.3.12.2 - 8 - Yorkville Dam, Fox River
Right Abutment, Note Warning Signage. (IDNR, 2006)

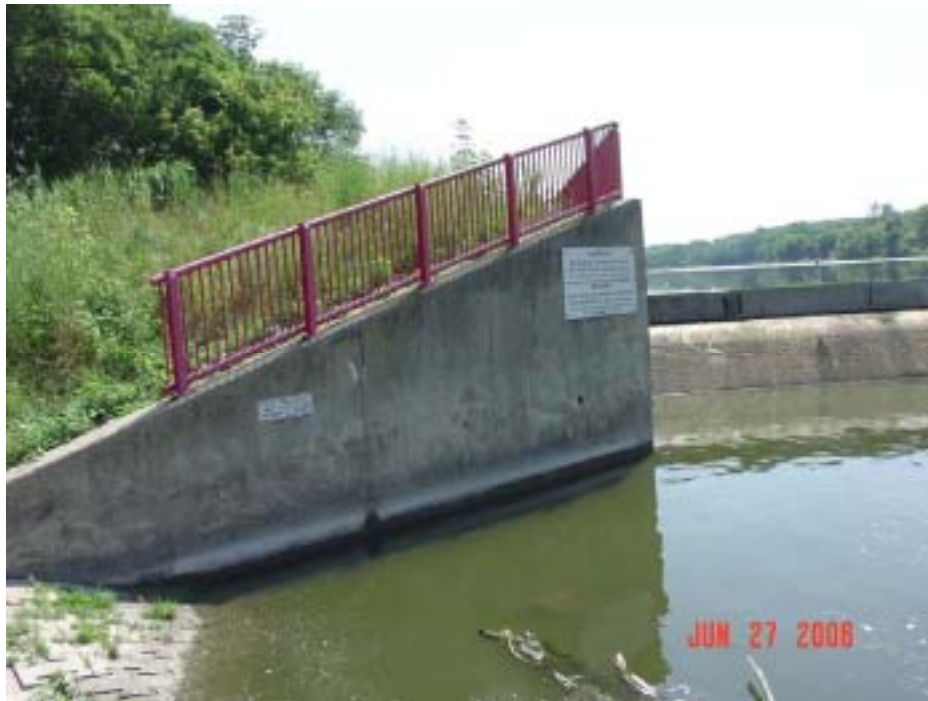
Photo 5.3.12.2 - 9 - Yorkville Dam, Fox River
Right Abutment and Warning Signs (IDNR, 2006)

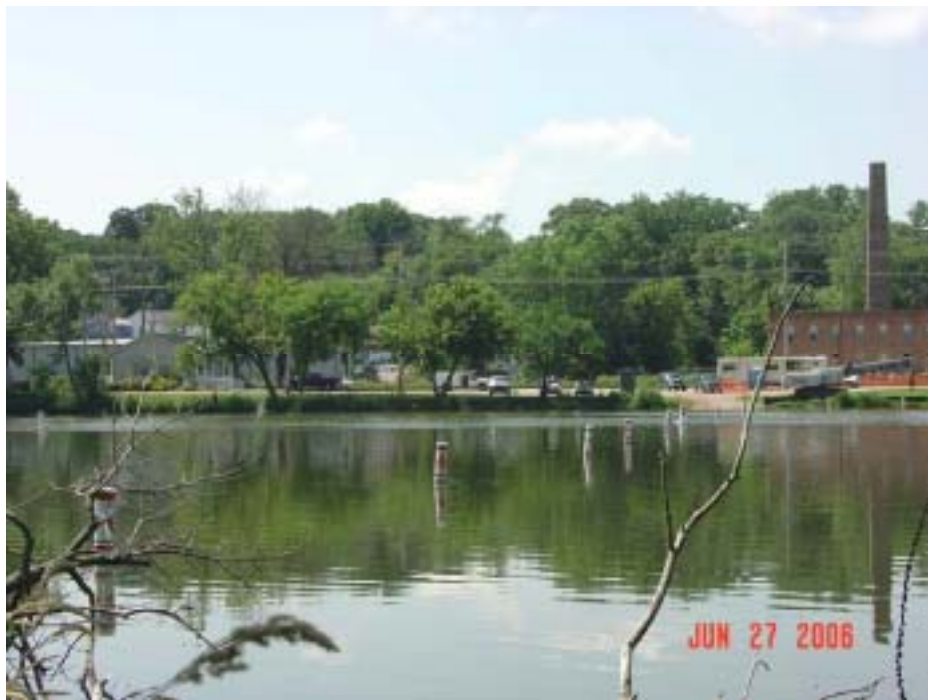
Photo 5.3.12.2 - 10 - Yorkville Dam, Fox River
Seasonal Warning Buoys. (IDNR, 2006)

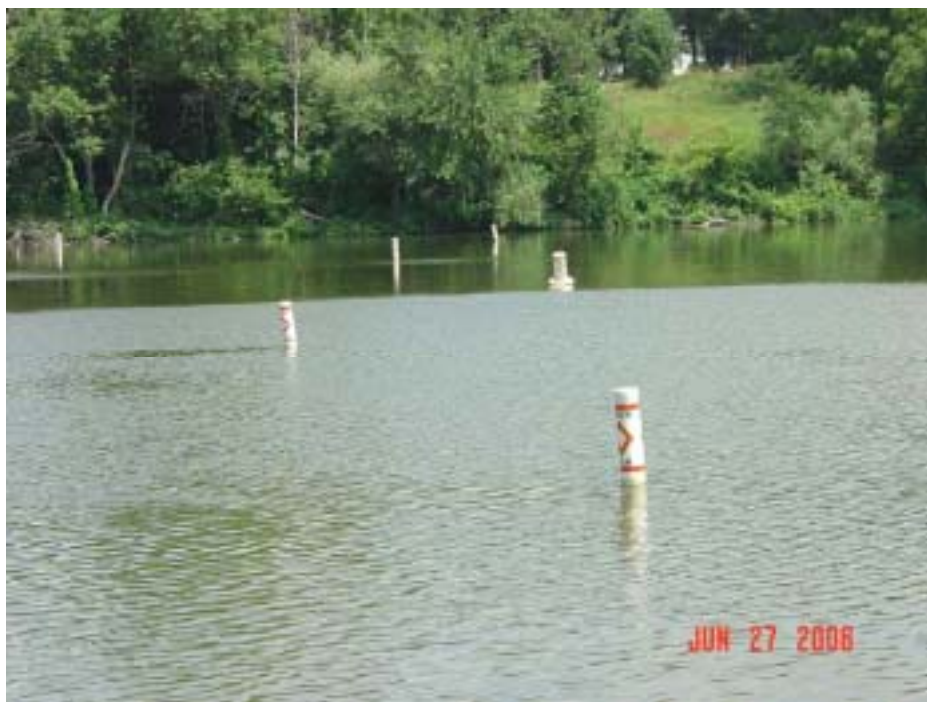
Photo 5.3.12.2 - 11 - Yorkville Dam, Fox River
Seasonal Warning Buoys. (IDNR, 2006)

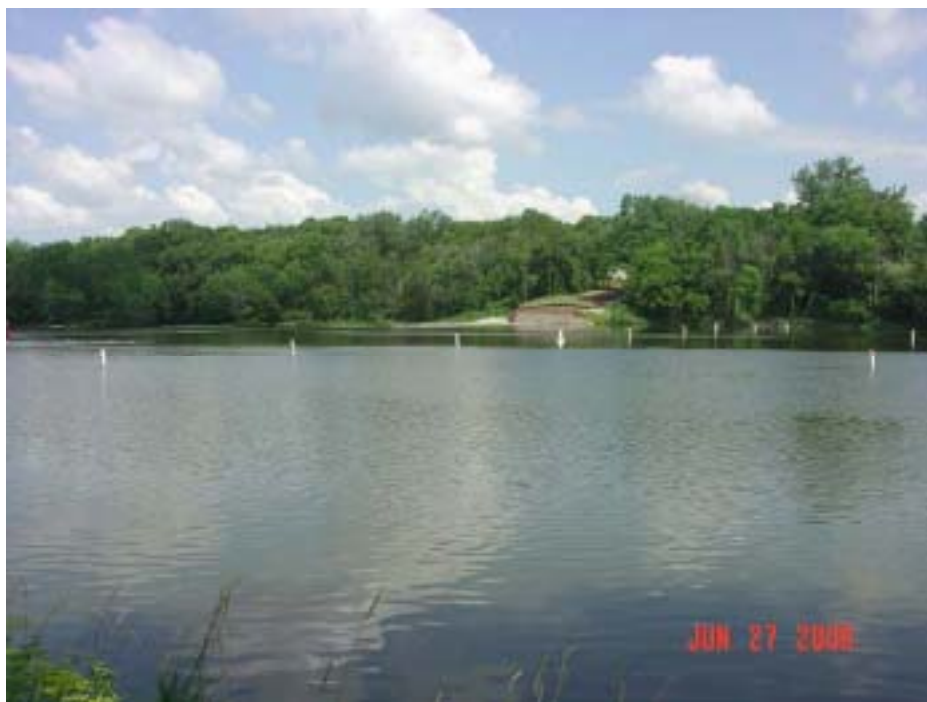
Photo 5.3.12.2 - 12 - Yorkville Dam, Fox River
Seasonal Warning Buoys. (IDNR, 2006)

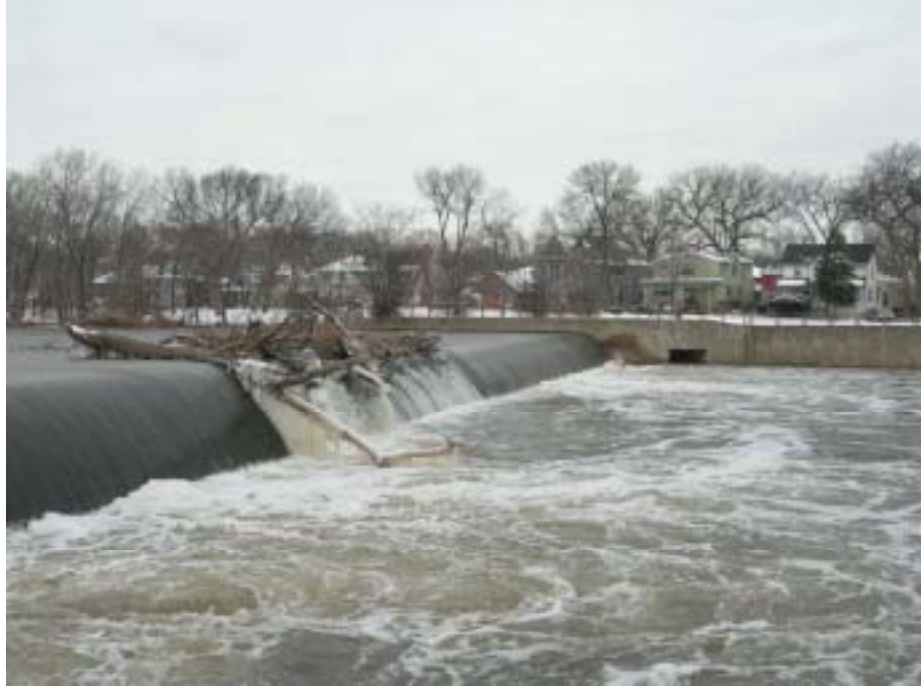
Photo 5.4.1.2 - 1 - Hofmann Dam, Des Plaines River
Dam face, taken from right abutment. Note roller.

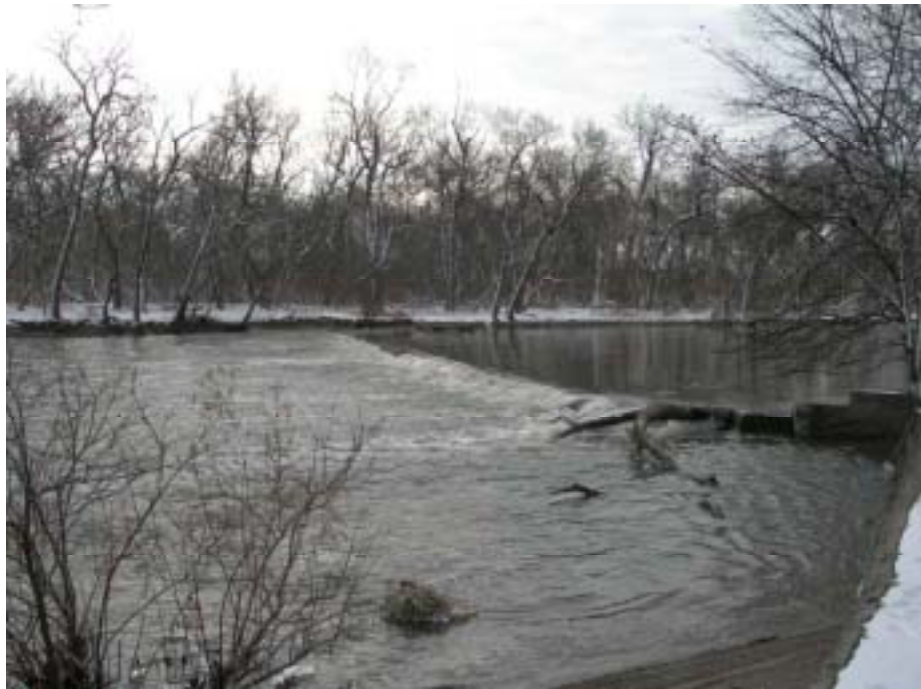
Photo 5.4.1.2 - 2 - Hofmann Dam, Des Plaines River
Downstream. Additional dam structure downstream of Hofmann dam.

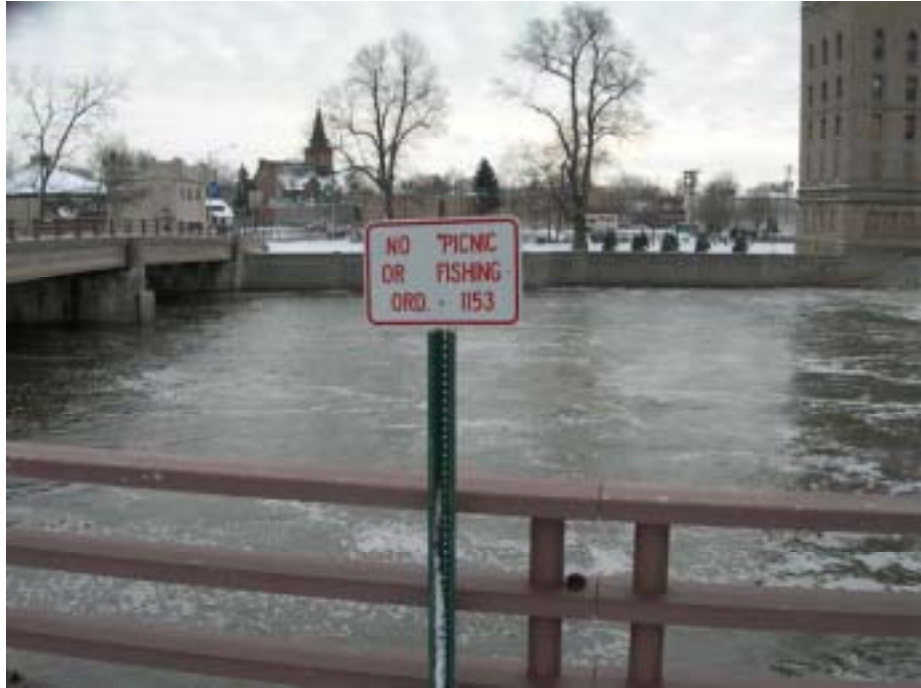
Photo 5.4.1.2 - 3 - Hofmann Dam, Des Plaines River
Downstream left bank. Village warning sign.

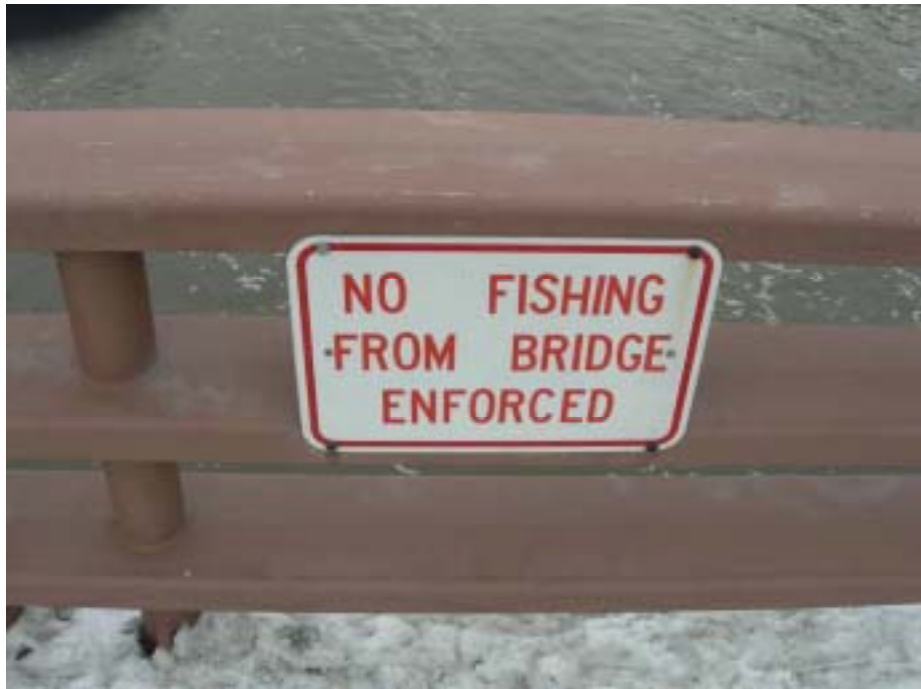
Photo 5.4.1.2 - 4 - Hofmann Dam, Des Plaines River
Bridge downstream of dam. Village warning sign.

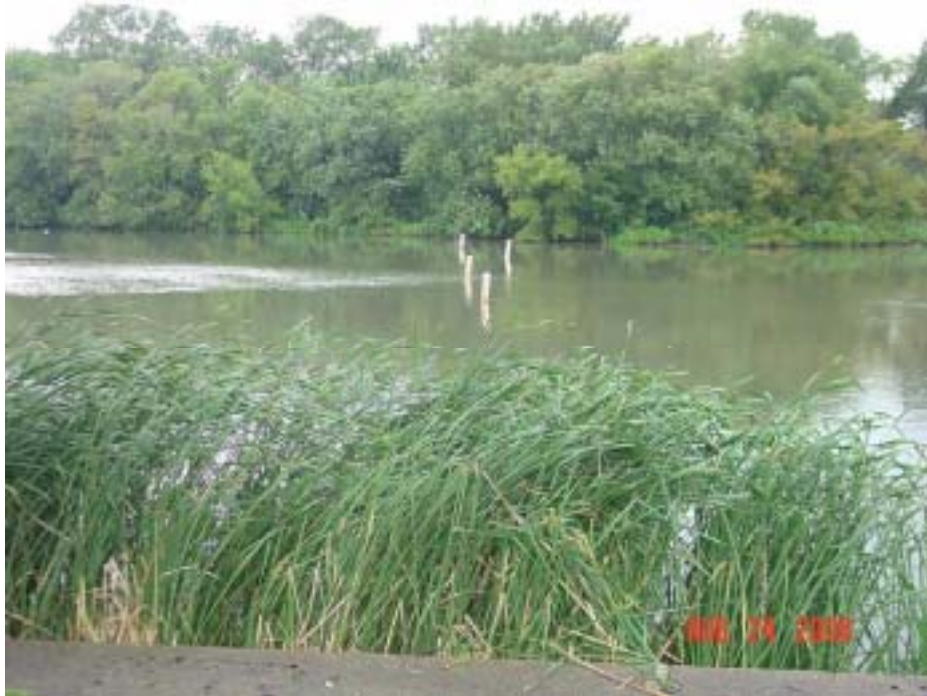
A single warning sign on Hofmann Tower warns river users "Danger Dam Ahead". This sign is readable to upstream boaters a possibly 30 feet. However, this sign may easily be missed and is a bit faded and not large enough. Other signage included warnings against picnicking and fishing at points near to the dam. No warning buoys were noted at this visual reconnaissance, however IDNR noted four (4) seasonal buoys upstream of the dam as shown on Figure 3.5.1.2-1 and Photo 3.5.1.2-5.

Photo 5.4.1.2 - 5 - Hofmann Dam, Des Plaines River
Seasonal Warning Buoys. (IDNR, 2006)

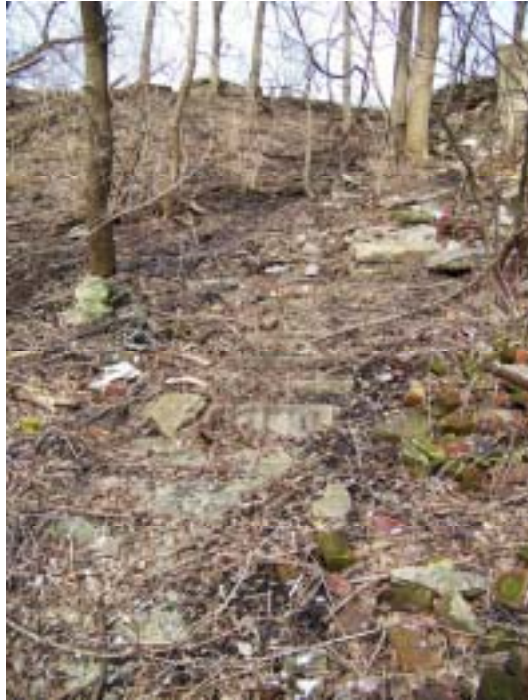
Access road to left bank located upstream of dam near S. Gilbert Road, but no direct access to dam was apparent. Slightly worn paths also noted down steep left embankment in vicinity of dam. Access road to right bank through private property. Partial steps located on left bank just upstream of dam.

Photo 5.5.1.2 – 1 – Danville Dam, Vermillion River
Steep left embankment where partial steps are located.

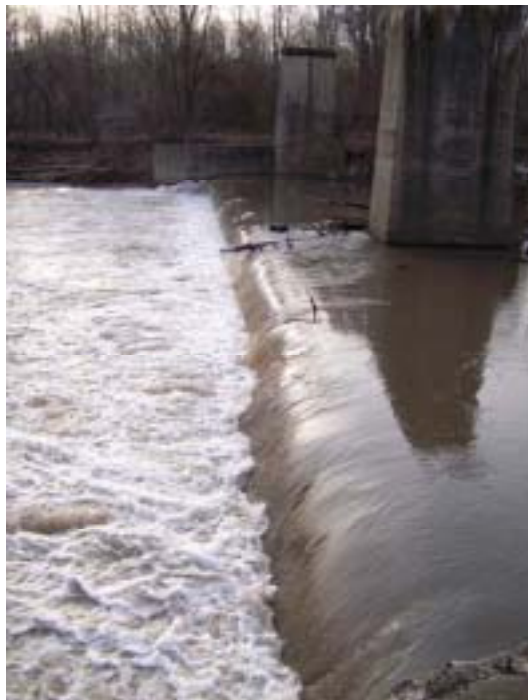
Photo 5.5.1.2 – 2 – Danville Dam, Vermillion River
Dam spillway with roller

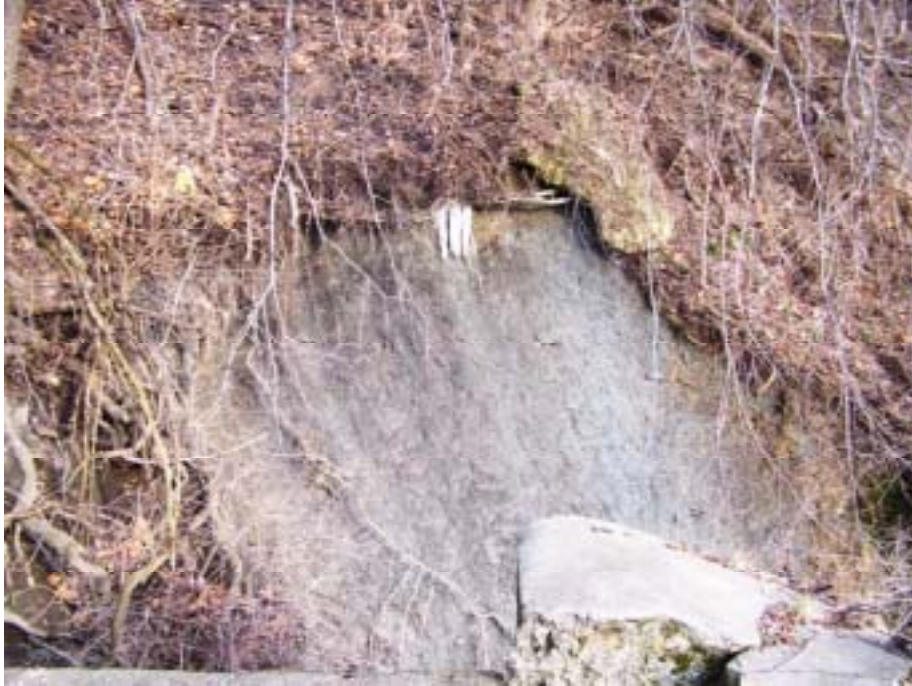
Spillway conditions could not be determined due to high flow. Abutments on left bank pulling away from dam. Significant erosion along right bank downstream of dam. Severe erosion of left bank immediately downstream of dam.

Photo 5.5.1.2 – 3 – Danville Dam, Vermillion River
Severe erosion located just downstream of dam on left bank

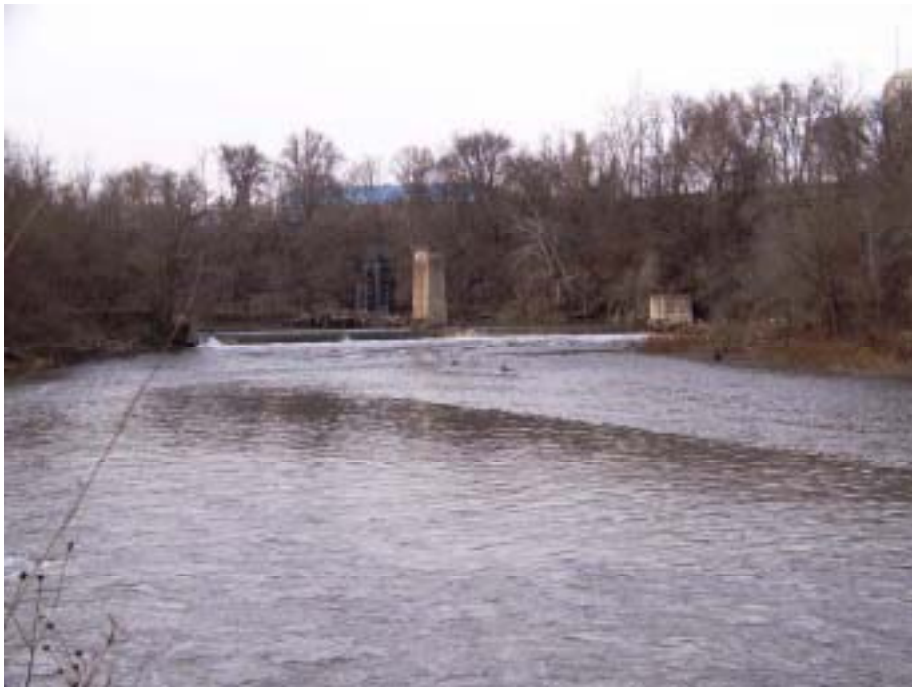
Photo 5.5.1.2 – 4 – Danville Dam, Vermillion River
Downstream of dam. Significant erosion on right bank

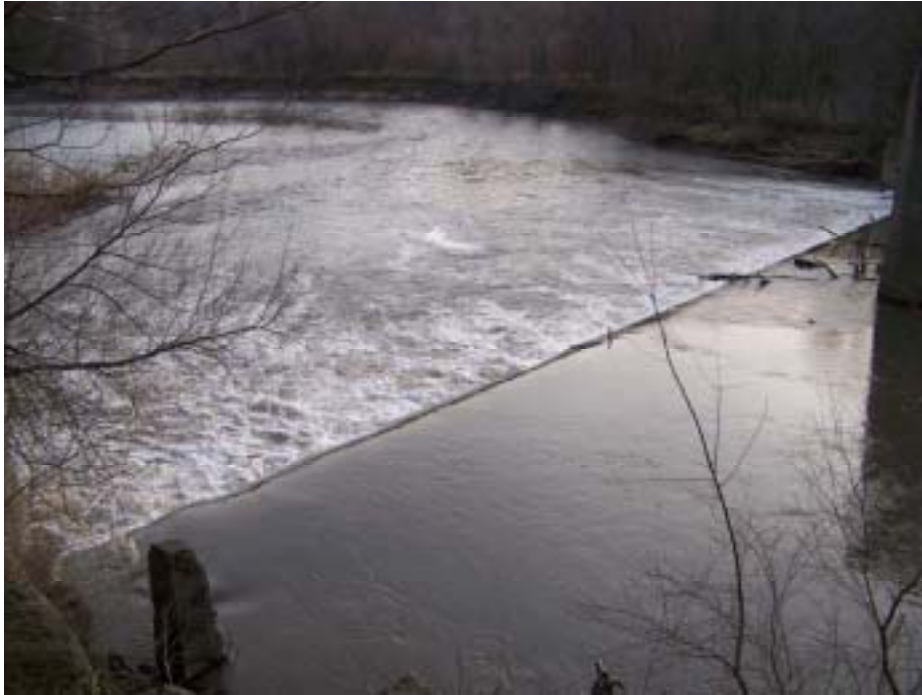
Significant roller observed.

Photo 5.5.1.2 – 5 – Danville Dam, Vermillion River
Dam Roller

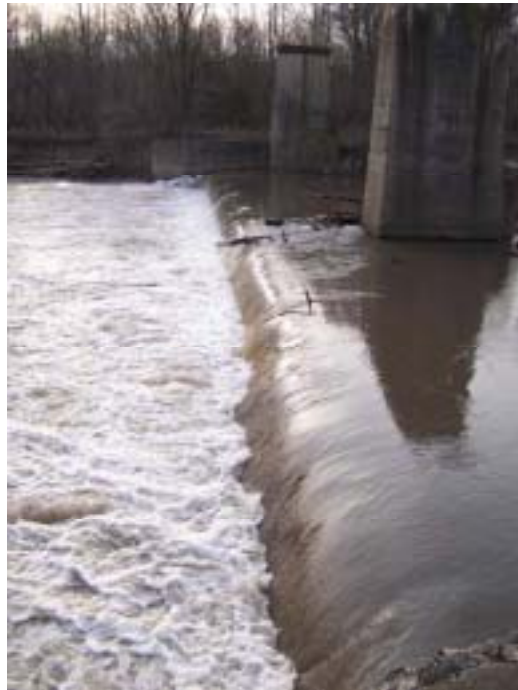
Photo 5.5.1.2 – 6 – Danville Dam, Vermillion River
Dam Roller

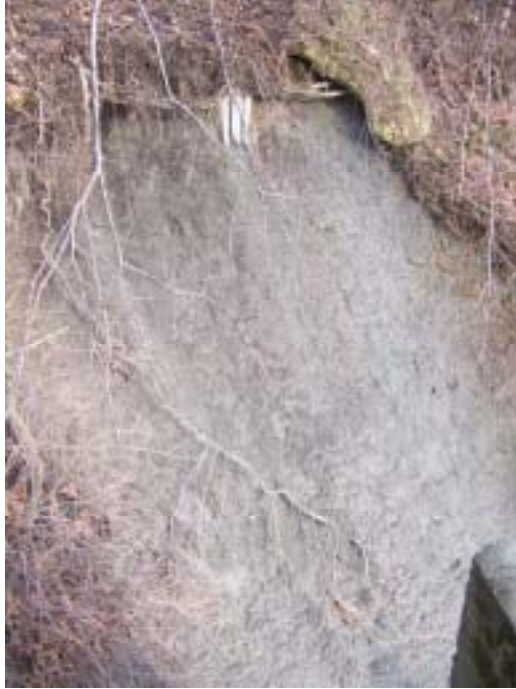
Photo 5.5.1.2 – 7 – Danville Dam, Vermillion River
Erosion on downstream left bank at dam abutment

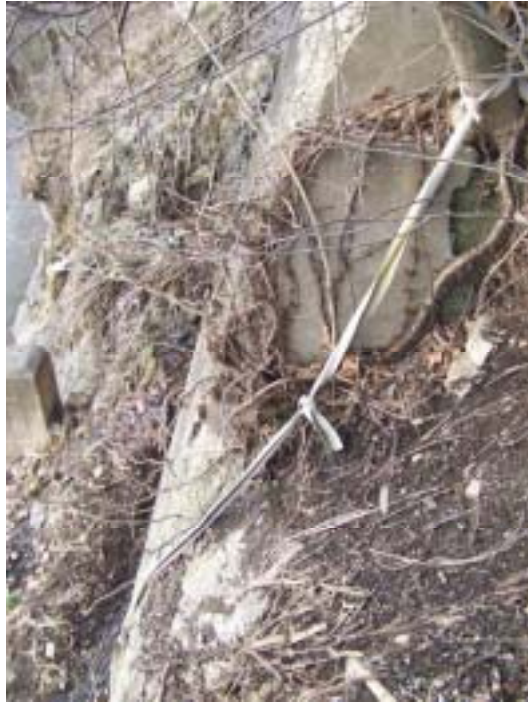
Photo 5.5.1.2 – 9 – Danville Dam, Vermillion River
Rope strap system for accessing left bank

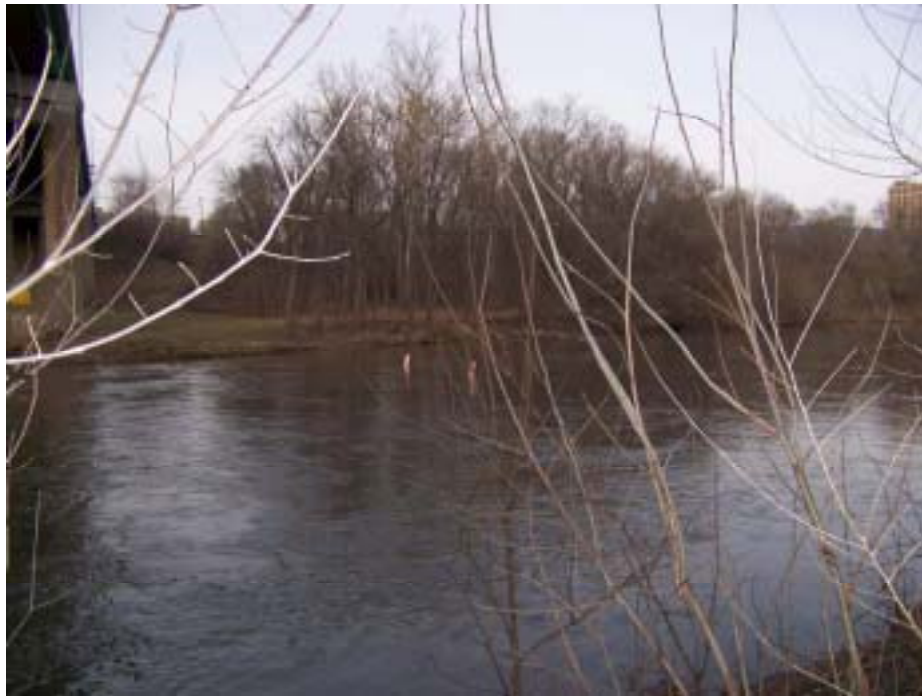
Warning signs located on left and right abutment piers of S. Gilbert Road. Two (2) warning buoys located downstream of S. Gilbert Road about 1400 ft. upstream on the dam were noted at this visual reconnaissance as shown on Figure 3.6.1.2-1 and Photo 3.6.1.2-10.

Photo 5.5.1.2 – 10 – Danville Dam, Vermillion River
Buoys downstream of highway bridge, upstream of dam
Note: warning signage found on bridge piers.

- 1) Lack of signage upstream; while there are buoys in the water under the bridge that warn of the dam, they could be missed and the signs painted on the bridge abutment are parallel to boaters and may not be seen unless boaters think to look.
- 2) Lack of portage information. There is no portage information at the dam and the left bank is too steep and does not provide for a portage location that canoeists can become trapped on the upstream left bank. Right bank is private property but could allow for portage.
- 3) The left bank is very steep, eroding and full of broken glass. It is so steep that users have a rope/strap system to transverse part of the bank. Fencing should be installed at the top of bank to keep people from attempting to traverse the bank.

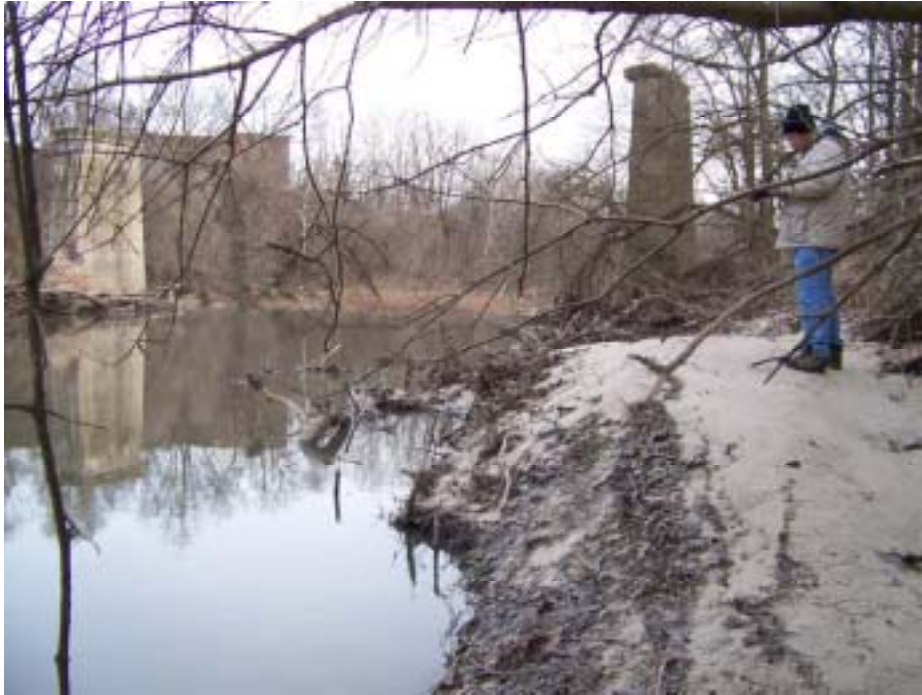
Photo 5.5.1.2 – 11 – Danville Dam, Vermillion River
Potential sand bar takeout location on right bank upstream of dam

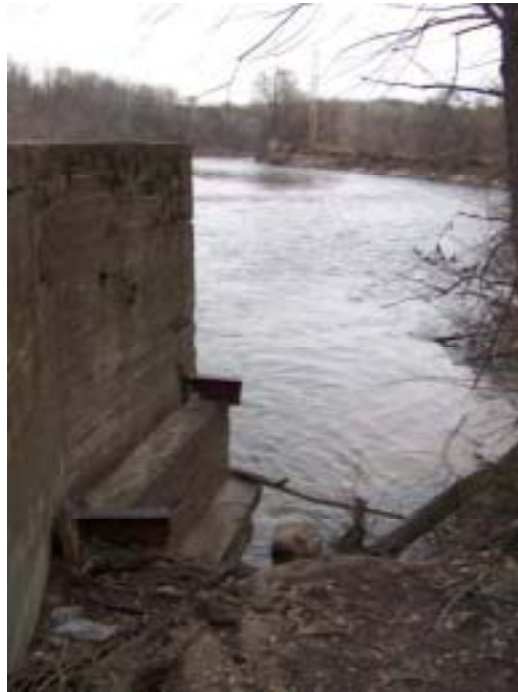
Photo 5.5.1.2 – 12 – Danville Dam, Vermillion River
Right bank downstream of dam

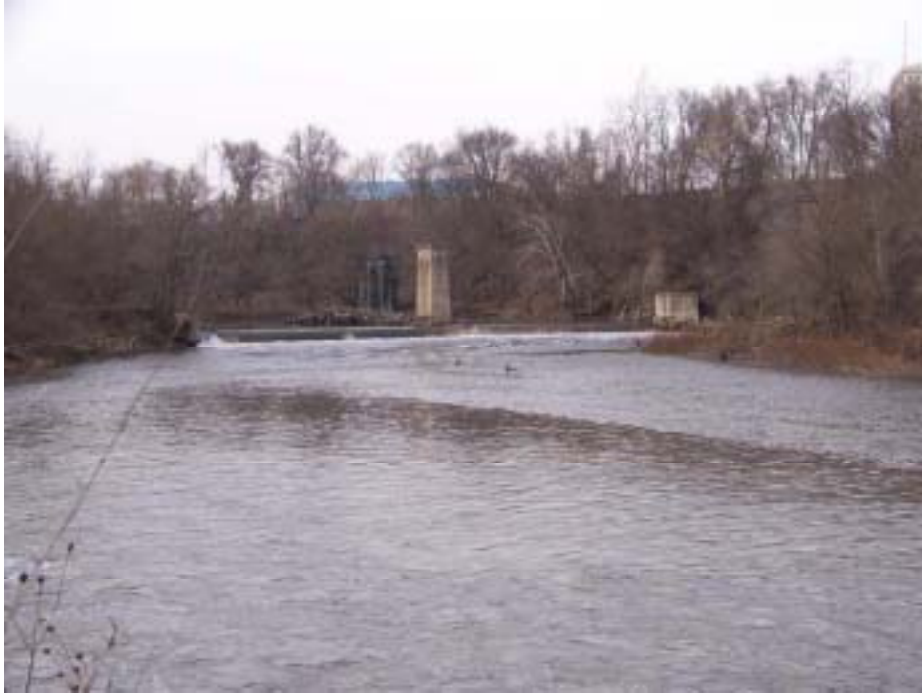
Photo 5.5.1.2 – 13 – Danville Dam, Vermillion River
Dam from downstream right bank

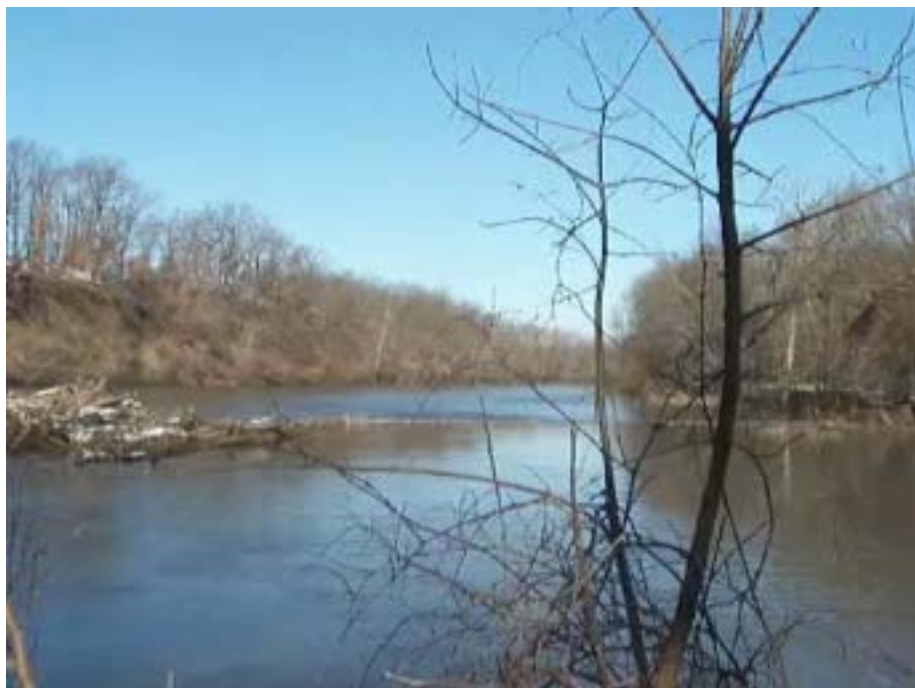
Photo 5.6.1.2 - 2 - Riverside Park Dam, Sangamon River
Looking downstream at right dam segment, submerged.

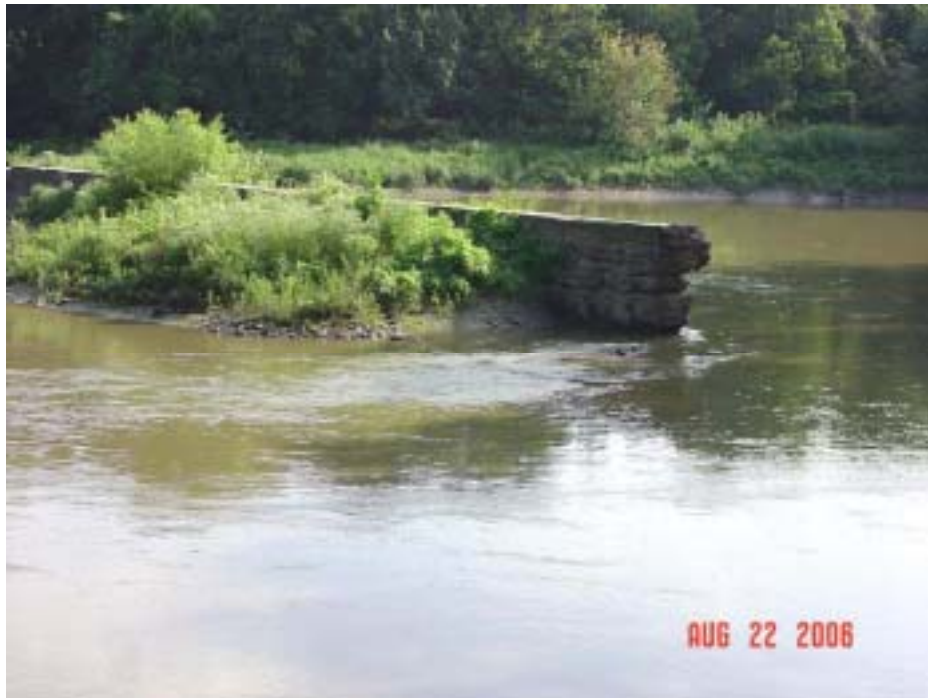
Photo 5.6.1.2 - 3 - Riverside Park Dam, Sangamon River
Dam Face, from Downstream. (IDNR, 2006)

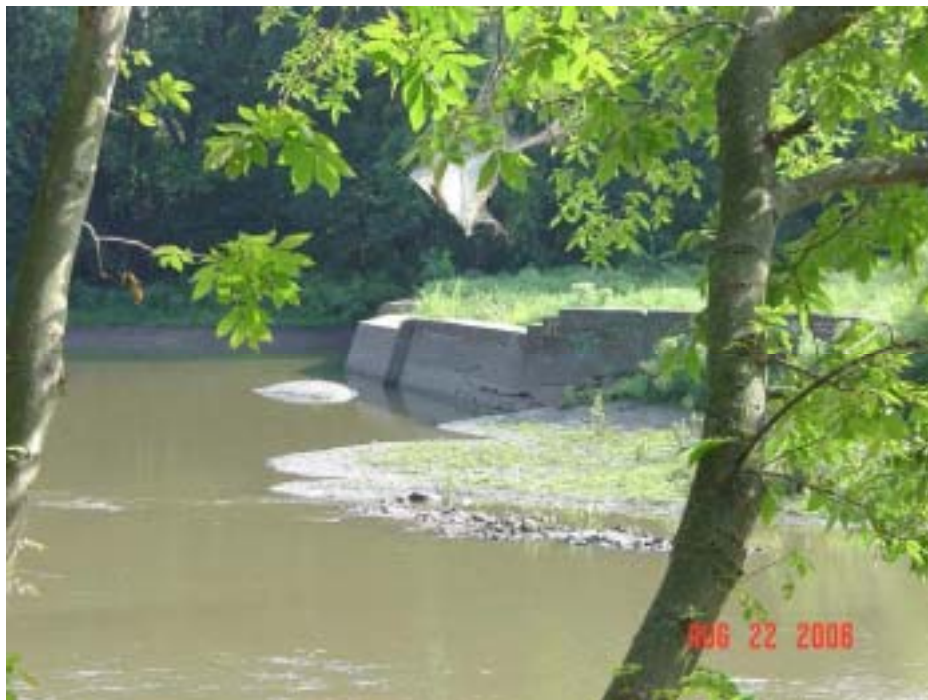
Photo 5.6.1.2 - 4 - Riverside Park Dam, Sangamon River
Dam Face, from Downstream (IDNR, 2006)

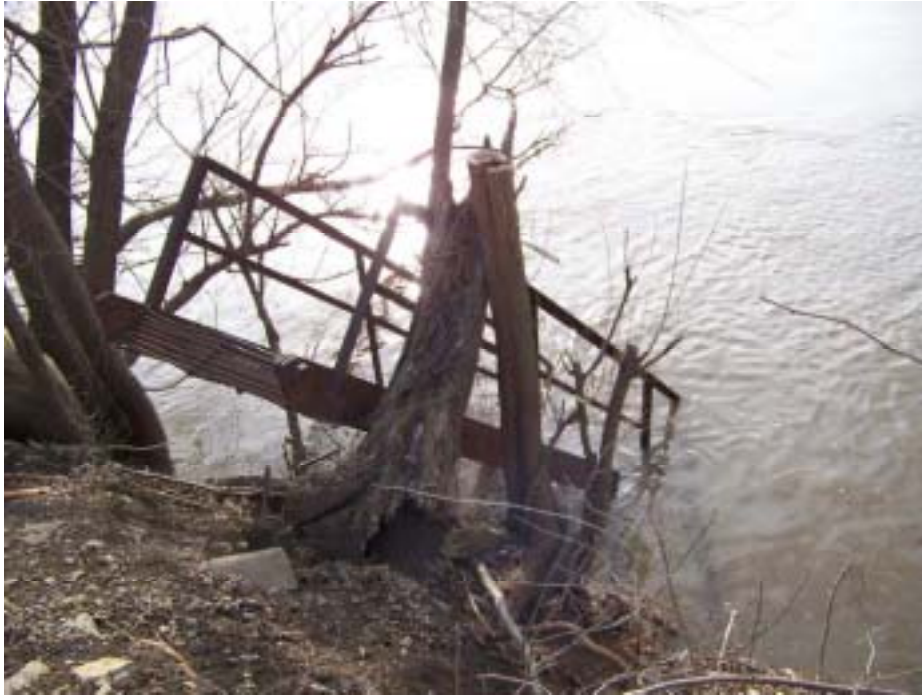
Photo 5.6.2.2 - 1 - Petersburg Dam, Sangamon River
Ladder for fisherman.

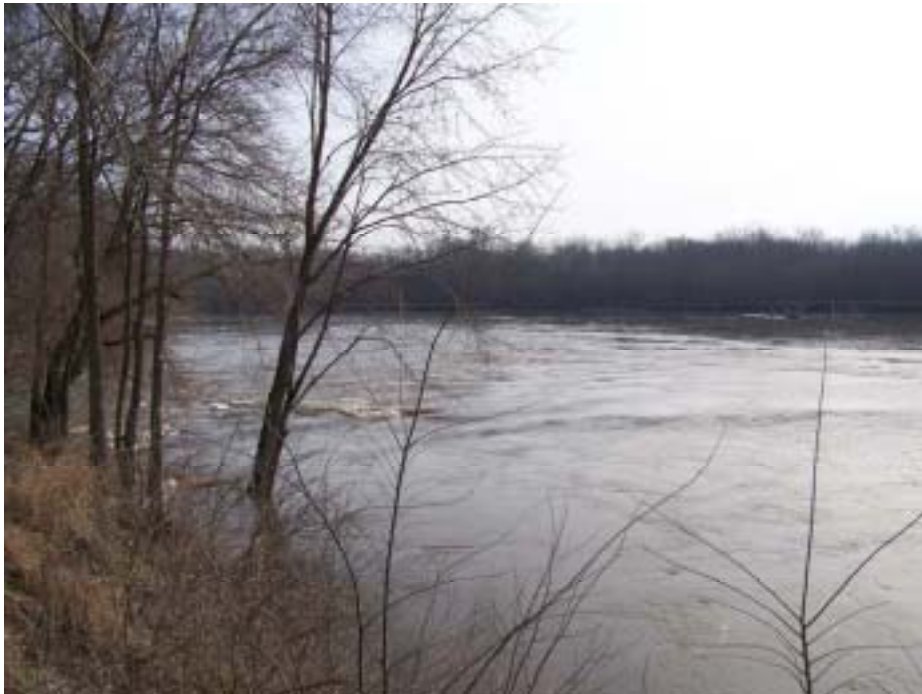
Dam was submerged during inspection so condition could not be determined. Later non-site investigation revealed that the dam has been breached.

Photo 5.6.2.2 - 2 - Petersburg Dam, Sangamon River
Submerged dam face, from left bank.

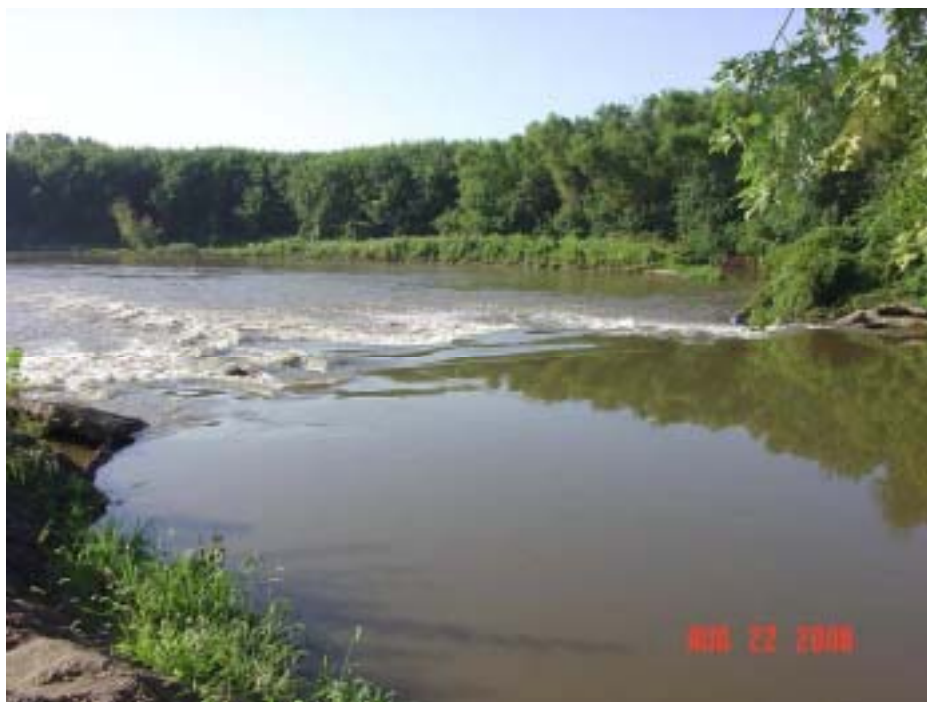
Photo 5.6.2.2 – 3 – Petersburg Dam, Sangamon River
Dam face, from left bank, summer. (IDNR, 2006)
